PRODUCT RELEASE NOTES

Product: Ponemah™ Physiology Platform

Version: 5.61

Date: August, 2023

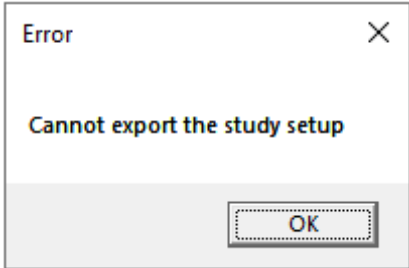
Reference #	Description
48407	<p>When attempting to export a Study setup or print LOGs, an Error message may be displayed indicating that the function cannot be executed. For example,</p>

<p>To correct this issue, navigate to C:\Ponemah\Utilities\ and run the AccessDatabaseEngine_x64.exe.</p>
49264	The RVW file name in the report header now updates correctly when choosing the "Save Review Protocol As" option and entering a different file name.
